Remediation of former Painswick Gasworks. Verification report for Beech Cottage

Report reference: 6819BR1, September 2008
Report status: Final

Confidential
Prepared by
ESI Ltd

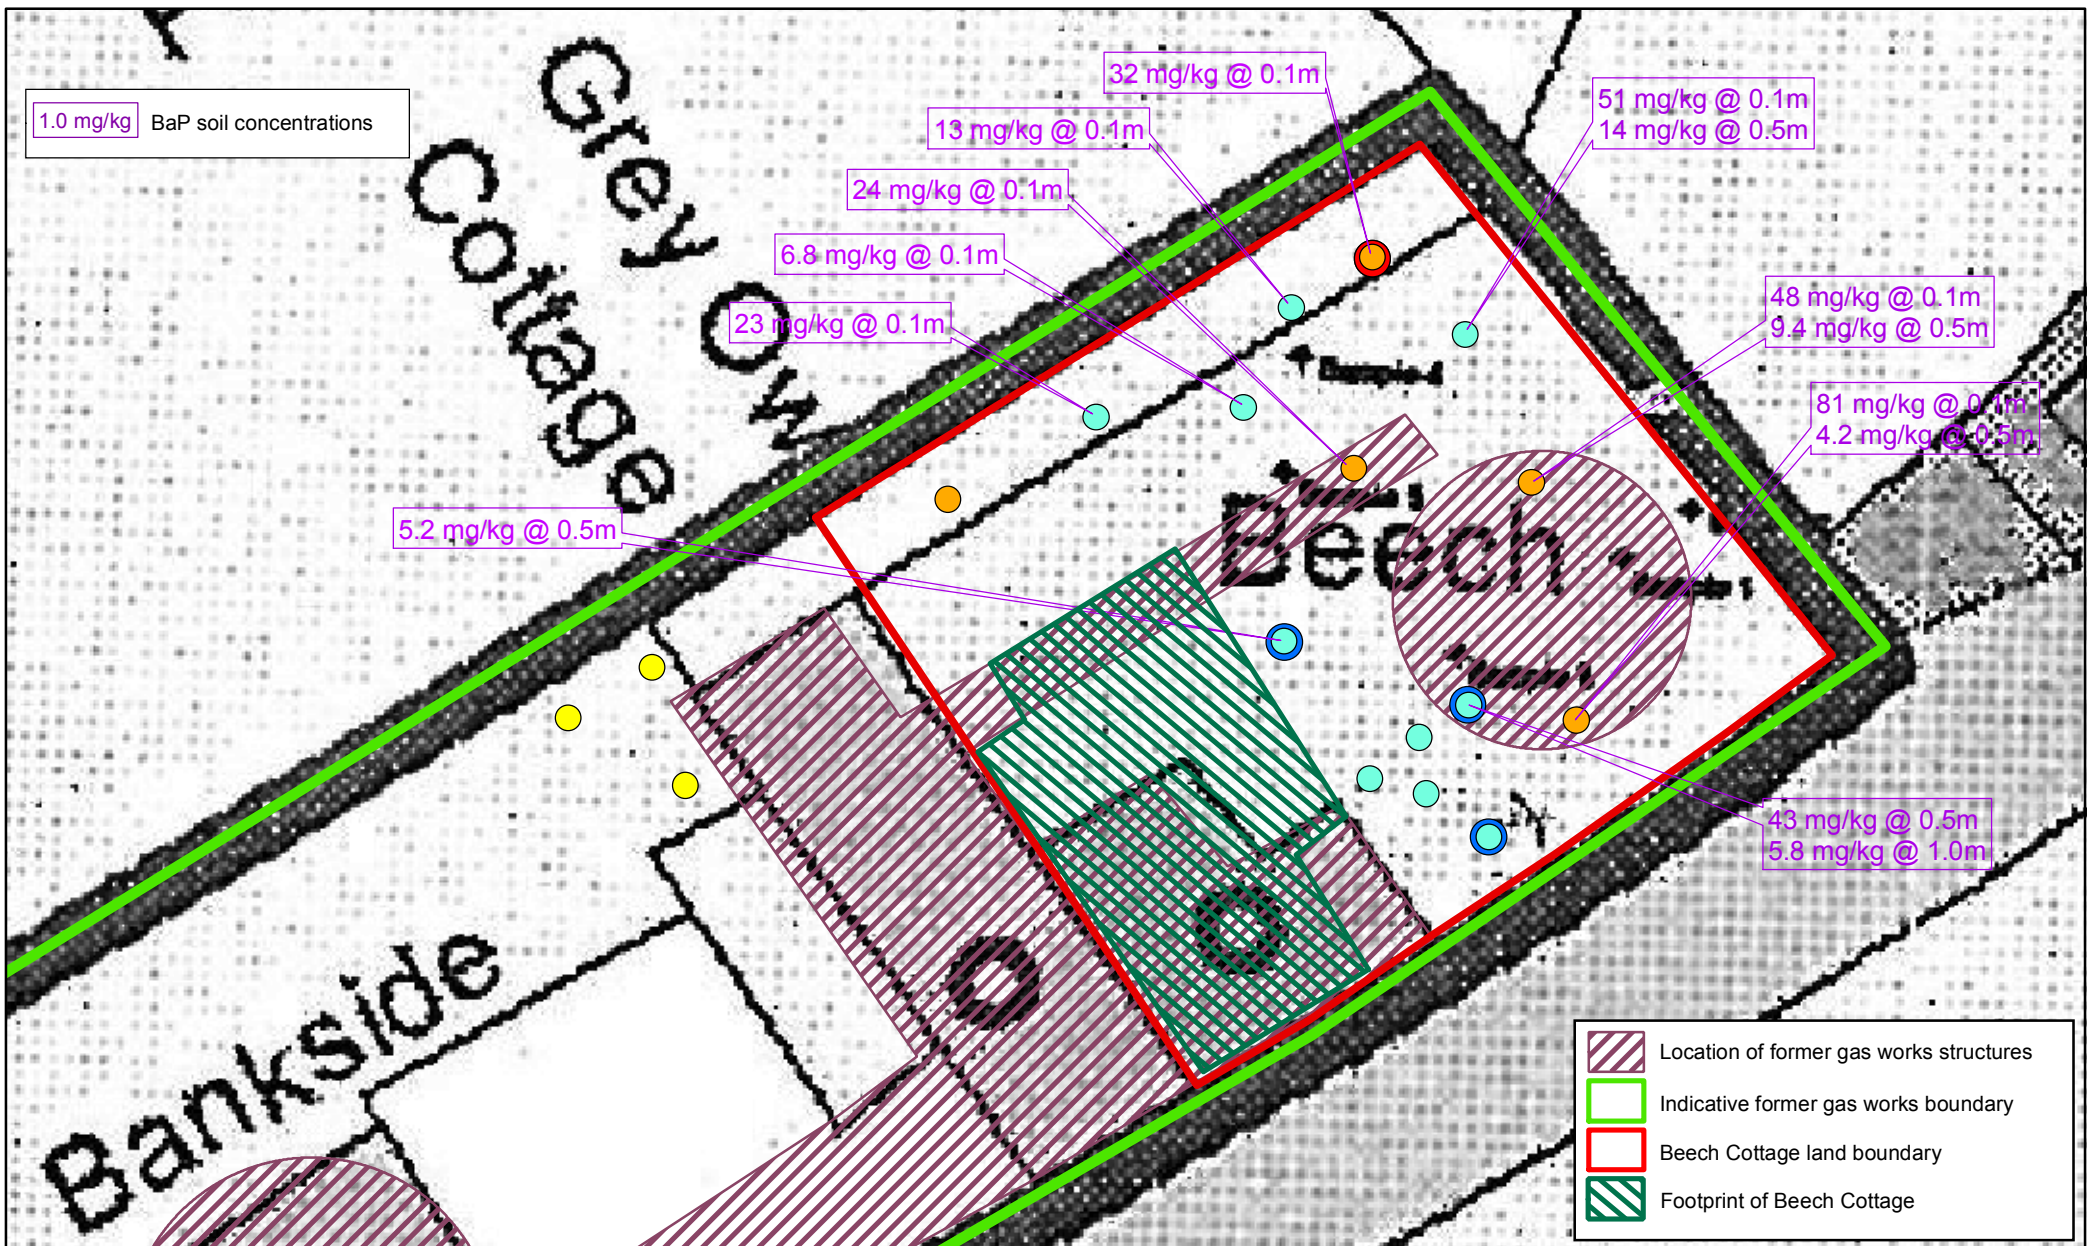
Figure 1.2
Contaminant distribution:
benzo (a) pyrene

The updated human health risk assessment concluded that potentially significant risks to human health are associated with the occurrence of elevated benzo(a)pyrene (B(a)P) in surficial soils across a wide area of Beech Cottage garden. Note: the risks associated with observed benzene concentrations are less well defined and consequently other investigations into the presence and potential significance of any vapour exposure pathways have been implemented for the site, including indoor air monitoring.

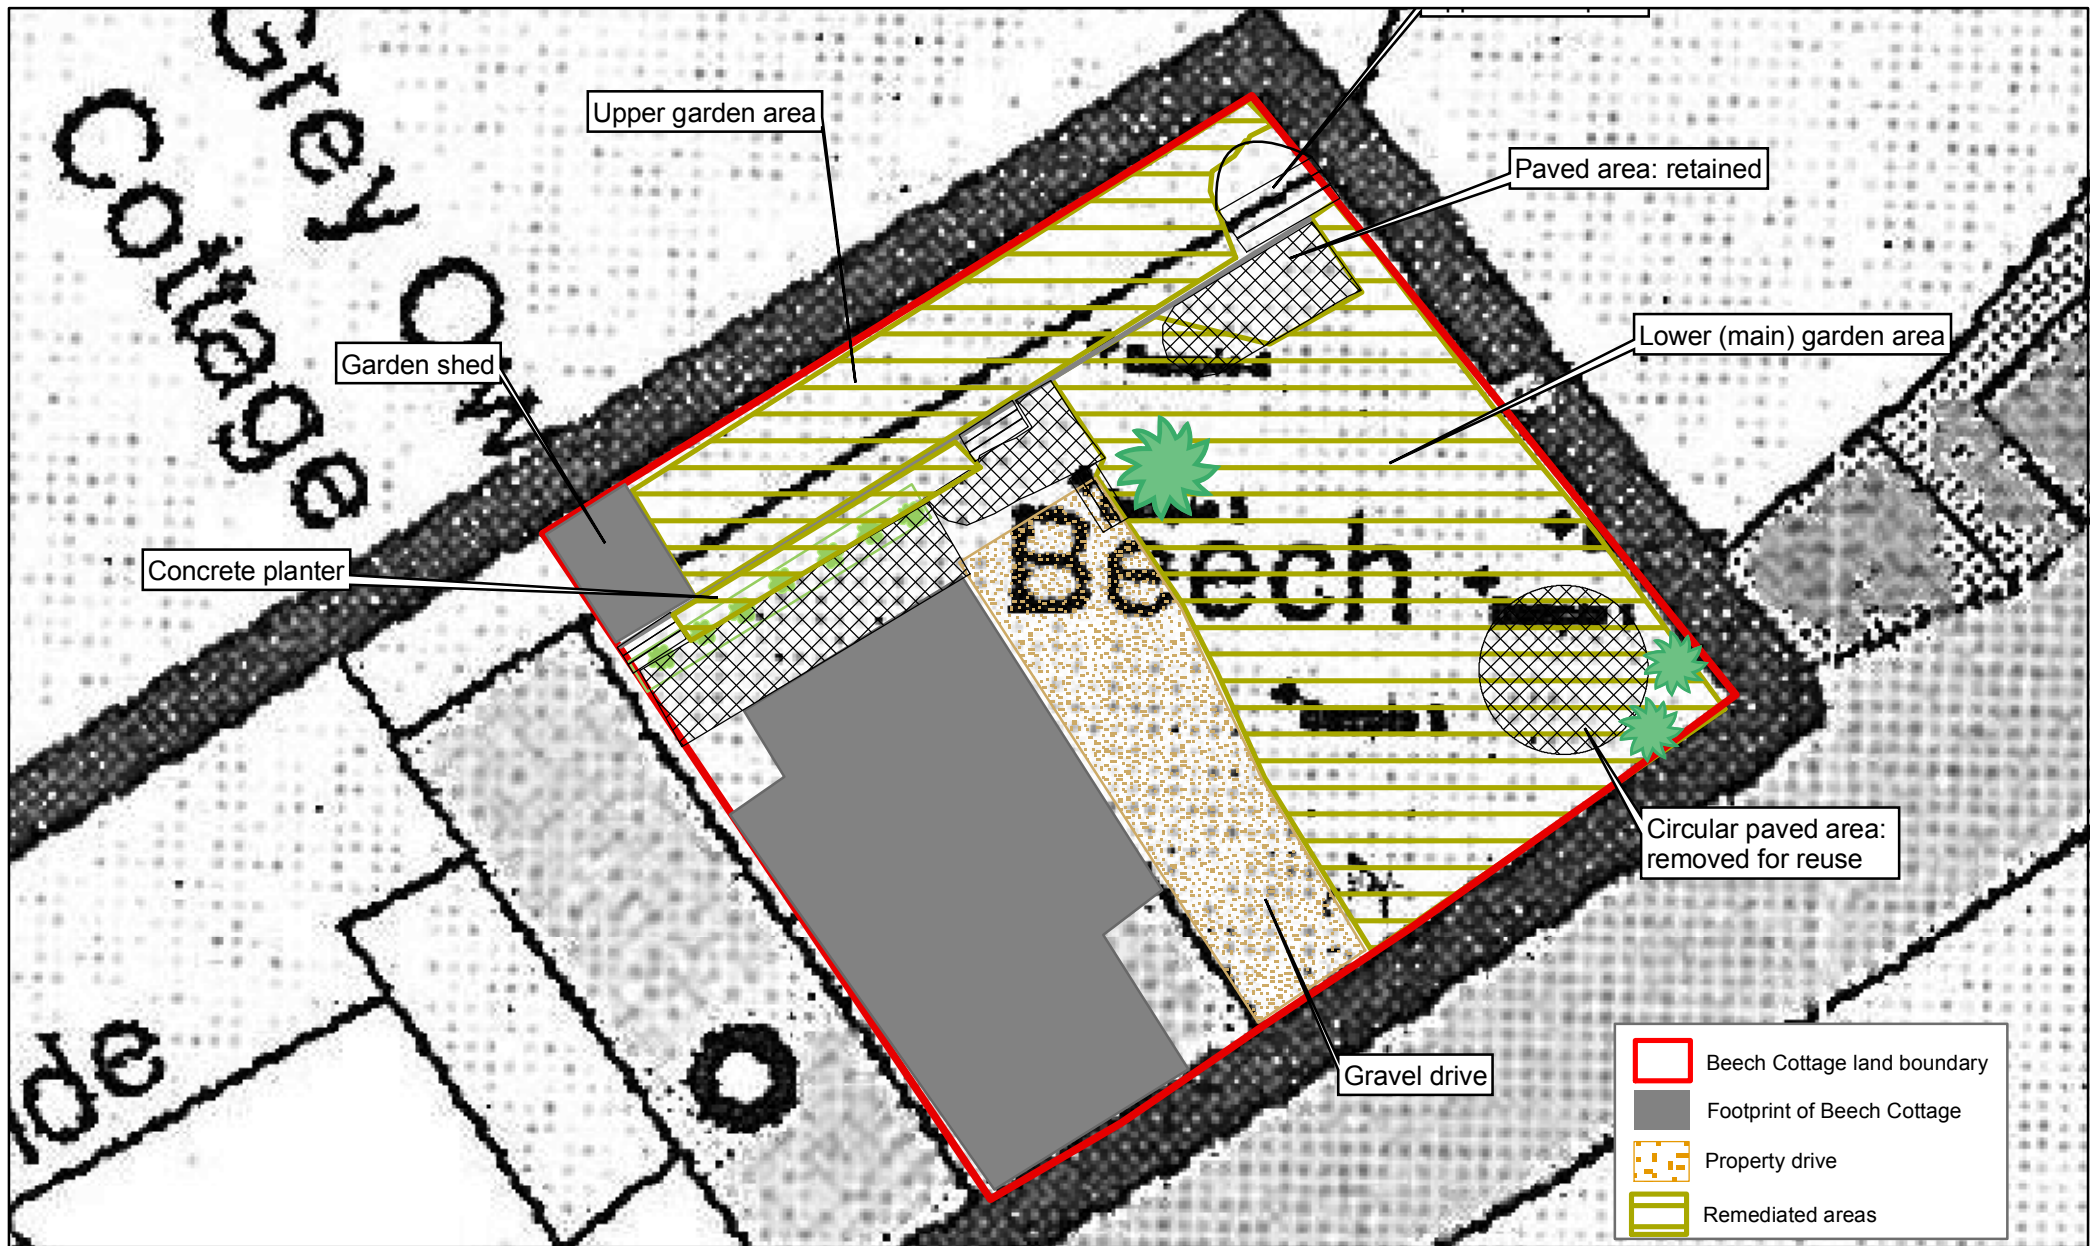
Figure 2.1
Excavated areas

The objective of the excavation works was to remove impacted soils from across the garden area to agreed depths which would either eliminate all contaminated material (as was the case across the raised garden tier to the rear of the property) or leave only limited material in place at a safe depth. As such, soil was removed from the upper garden tier typically to a 0.3 m depth, whereas soils across the main garden were taken down to approximately 0.6 m bgl (although a shallow dig was permitted in certain parts of the main garden - see below); the extent of the excavations is shown on Figure 2.1.

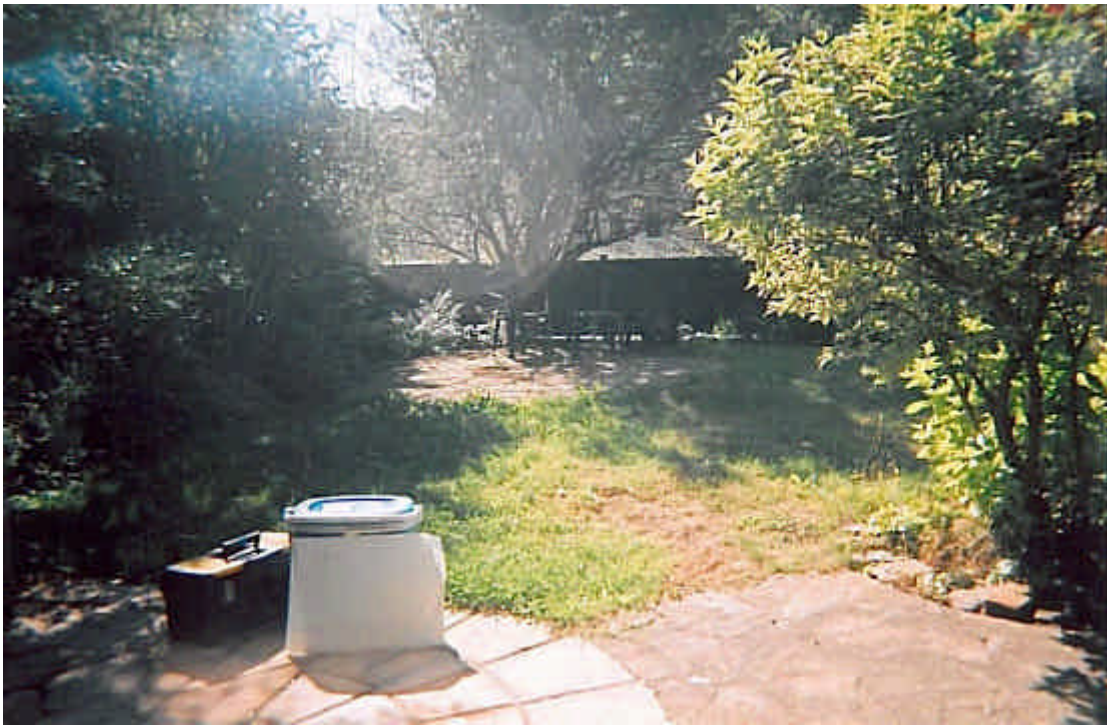
Photograph 1: Beech Cottage main garden: prior to remediation (July 2006)

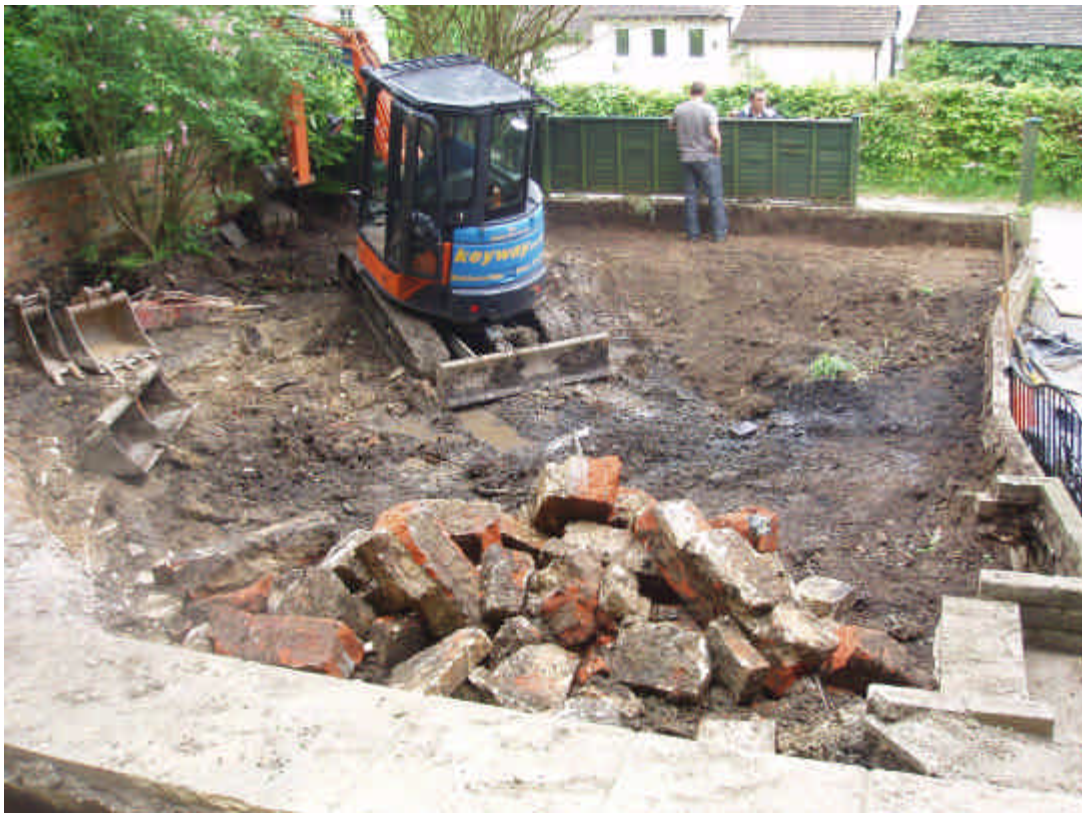
Photograph 2: Beech Cottage main garden during works (May 2008)

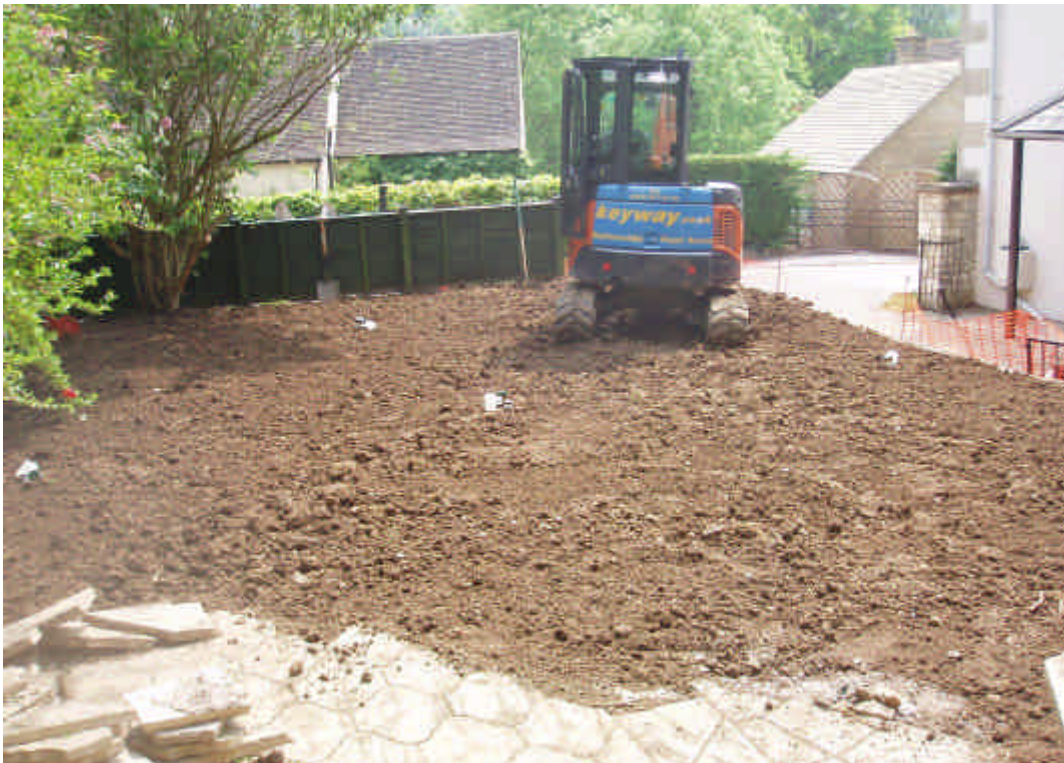
Photograph 3: Beech Cottage main garden after backfill (May 2008)

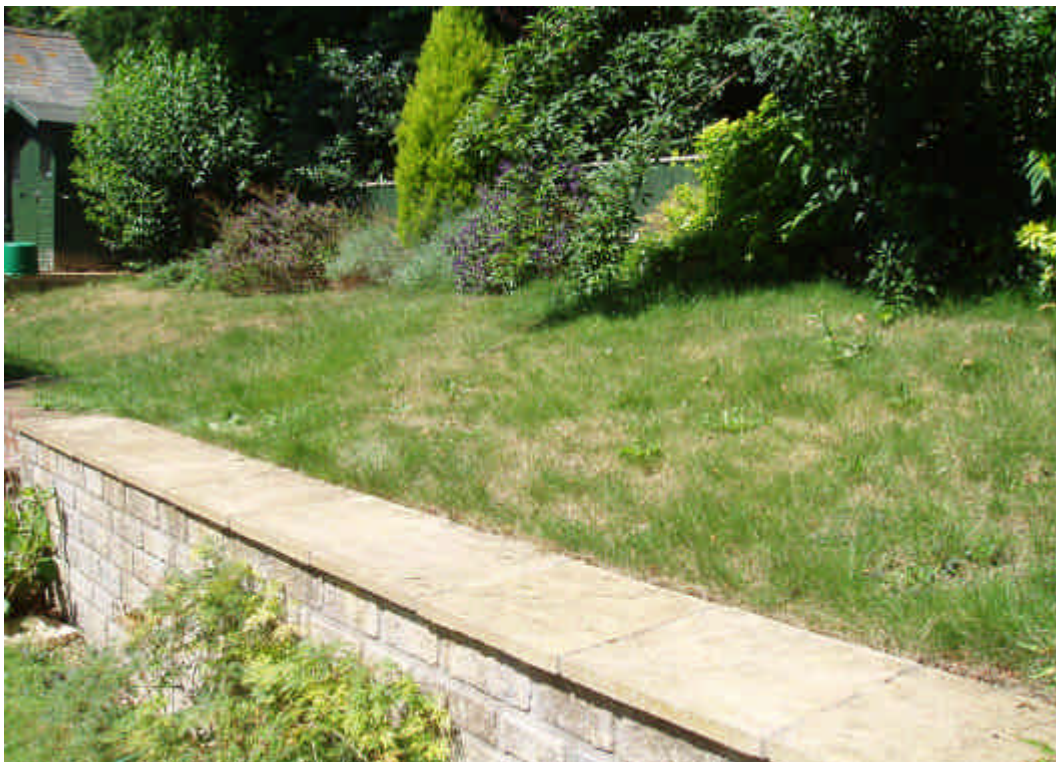
Photograph 4: Beech Cottage raised garden area to rear of property: prior to remediation (July 2006)

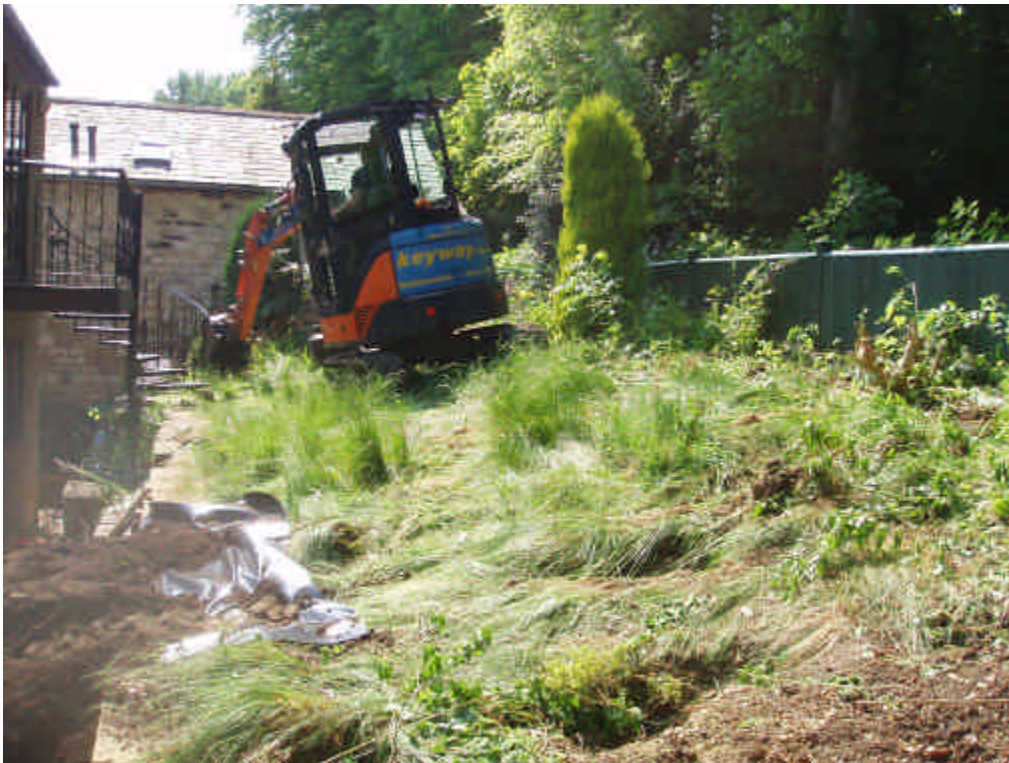
Photograph 5: Beech Cottage raised garden area during works (May 2008)

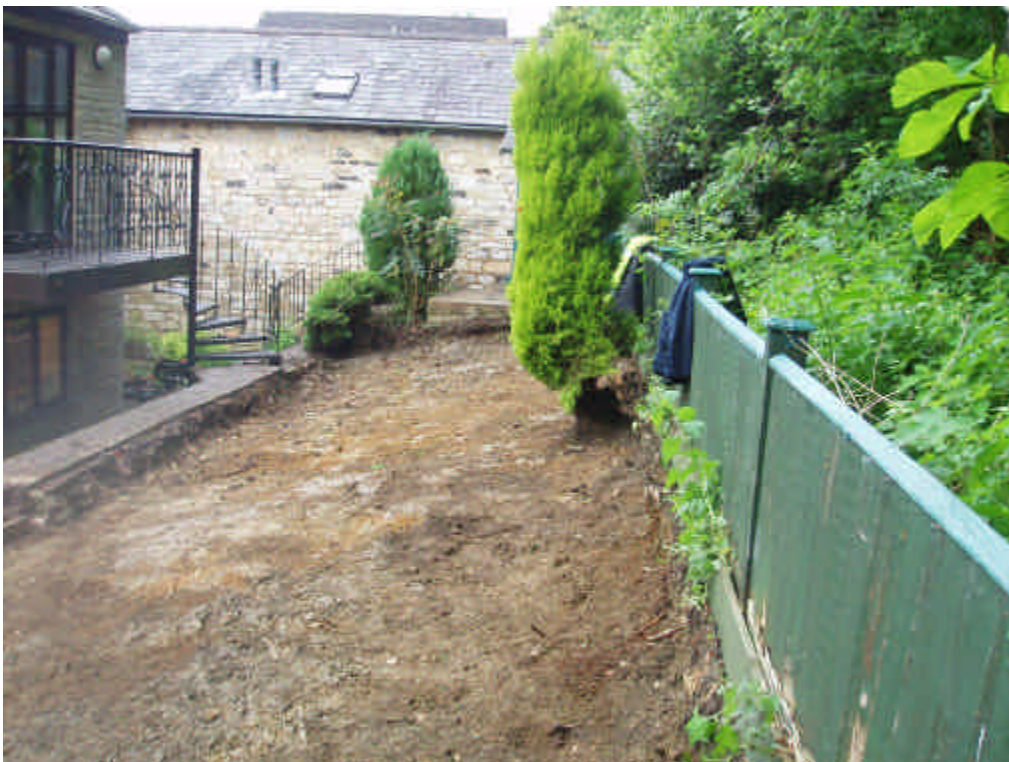
Photograph 6: Beech Cottage raised garden after excavation (May 2008)

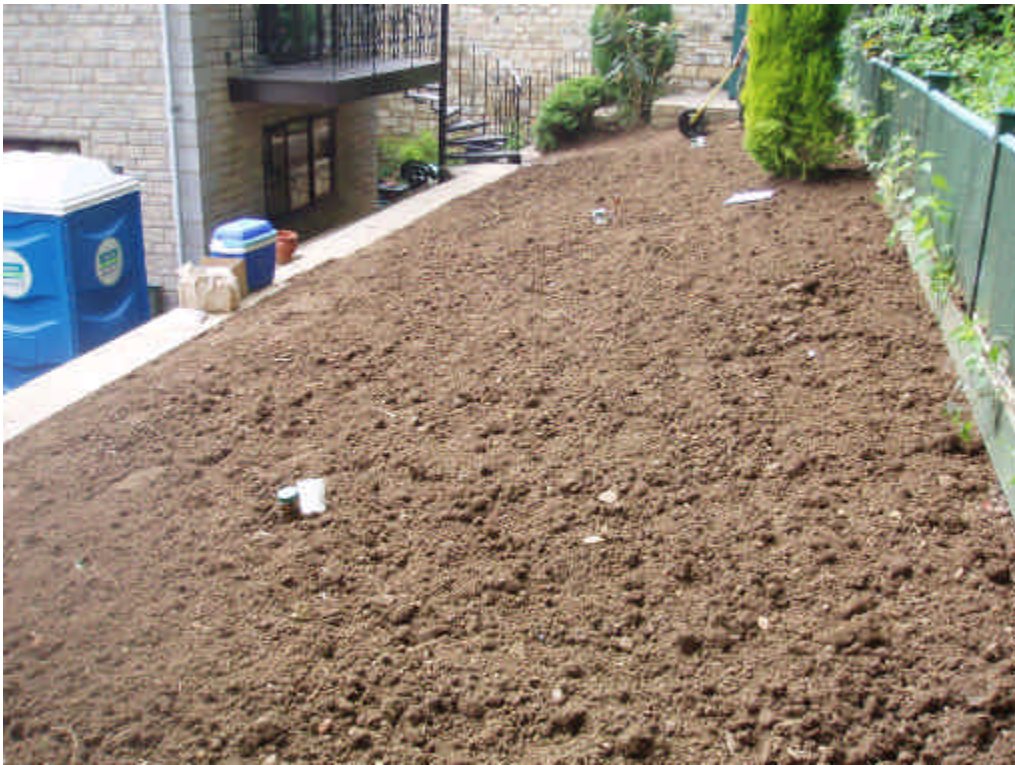
Photograph 7: Beech Cottage raised garden area after backfill (May 2008)

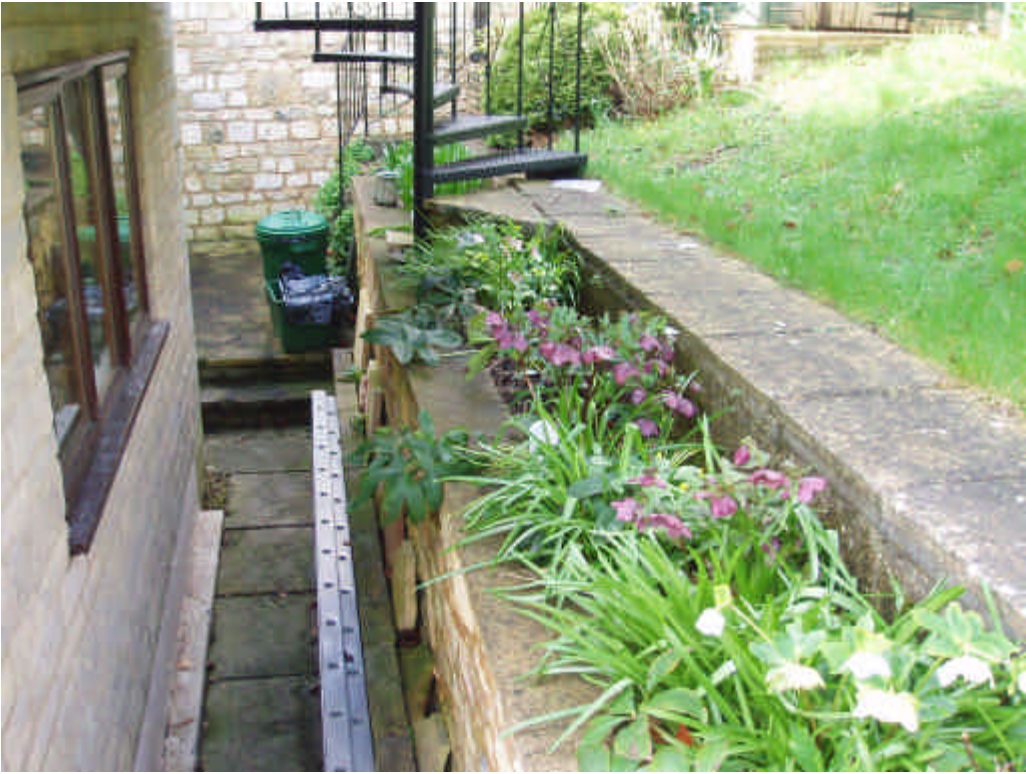
Photograph 8: Raised flower bed to rear of property (March 2007)

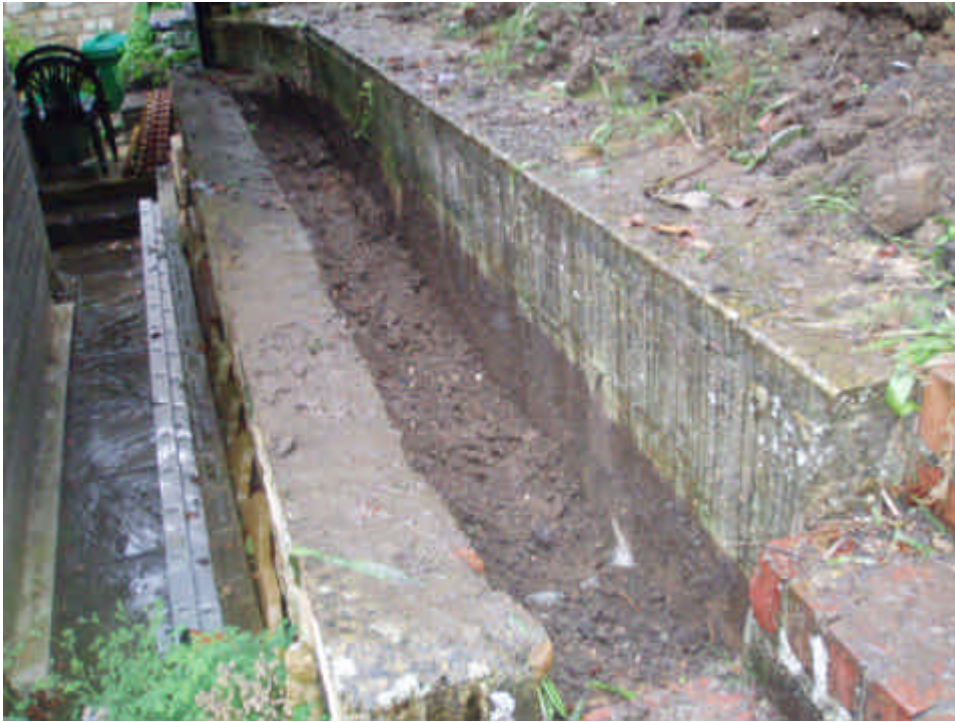
Photograph 9: Raised flower bed after excavation (May 2008)

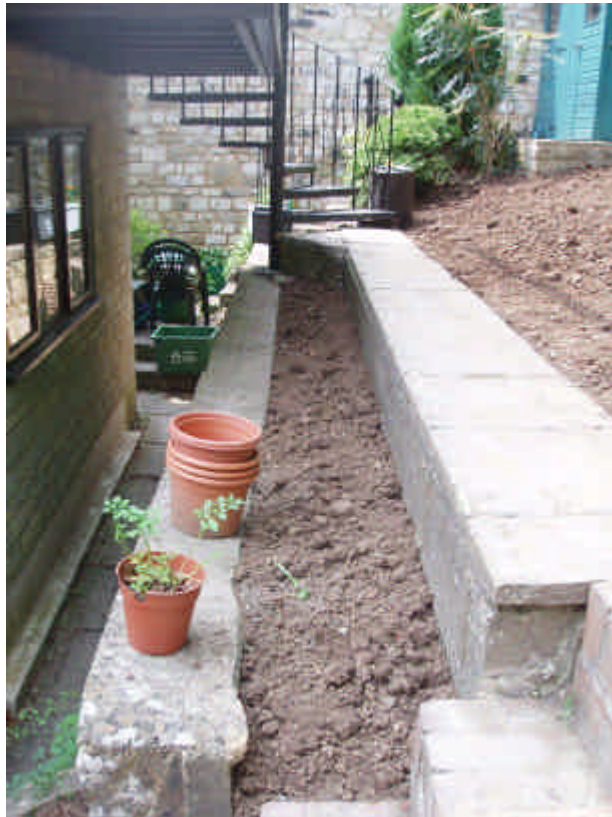
Photograph 10: Raised flower bed after backfill (May 2008)

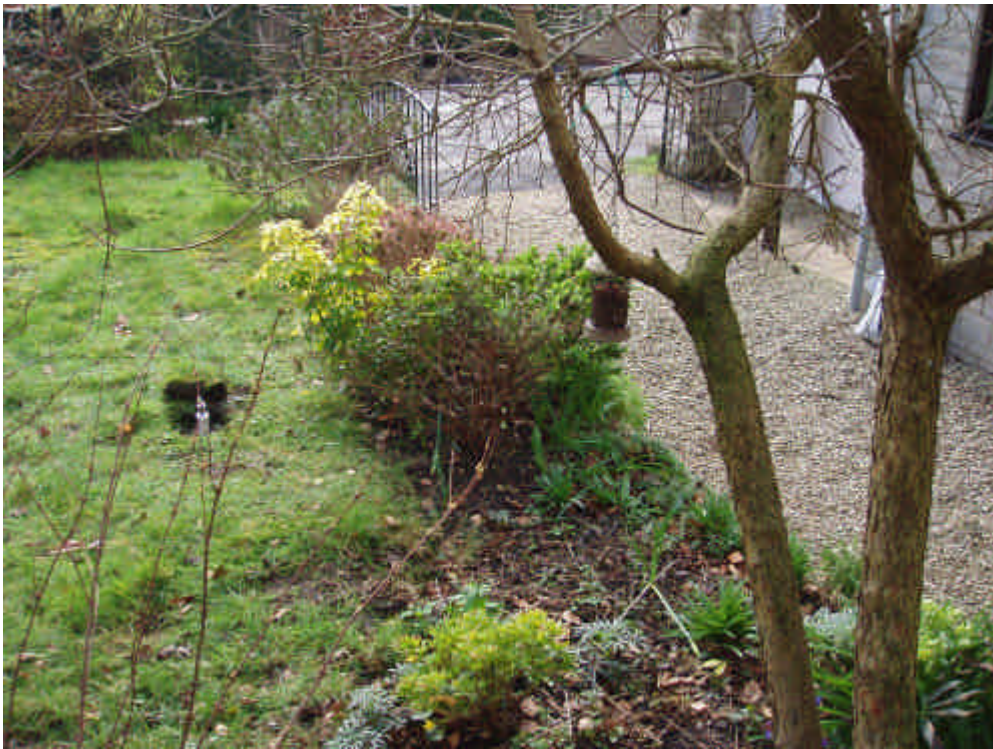
Photograph 11: View of main garden and driveway: prior to remediation (March 2007)

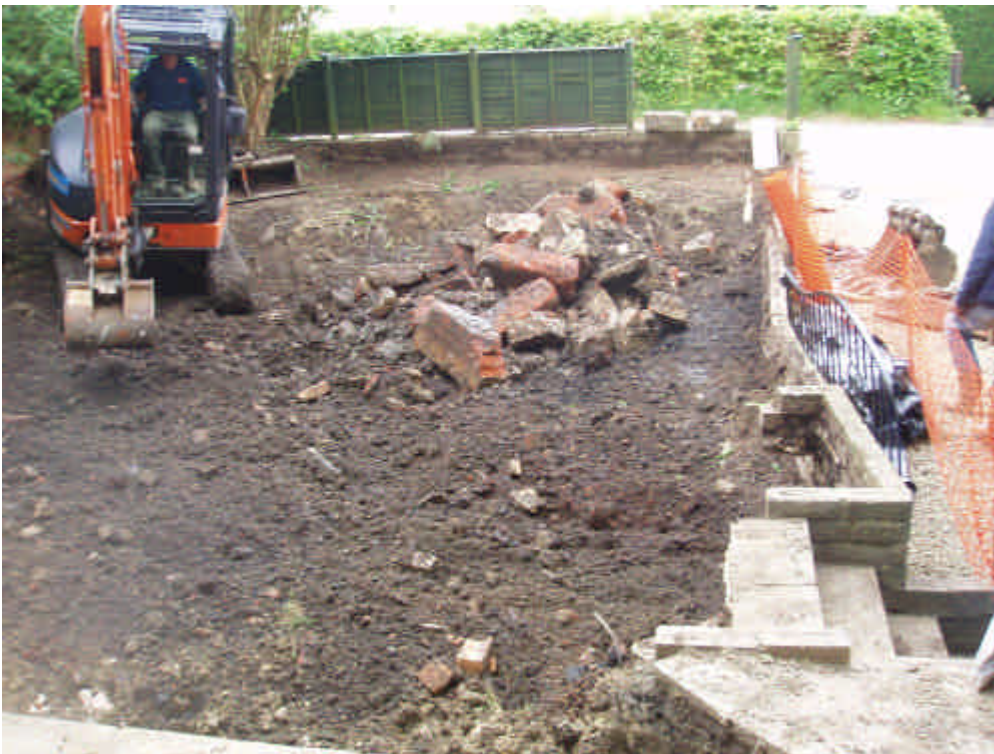
Photograph 12: View of main garden and driveway during works (May 2008)

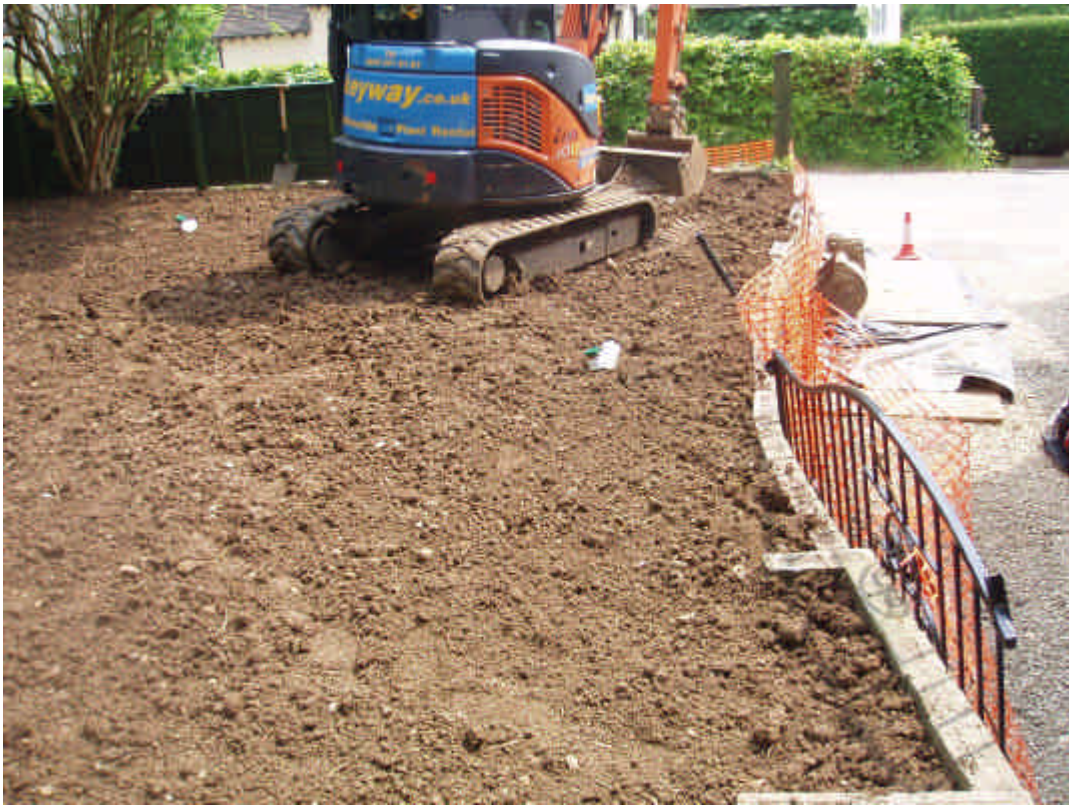
Photograph 13: View of main garden and driveway after backfill (May 2008)

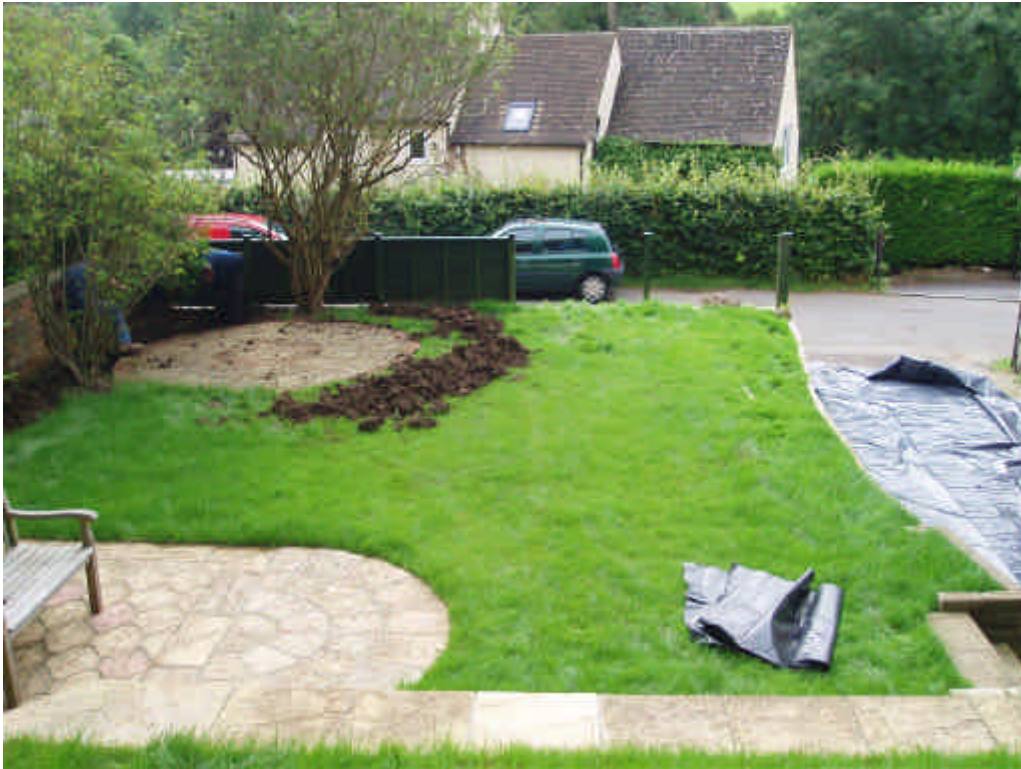
Photograph 1: Beech Cottage main garden at start of works (August 2008)

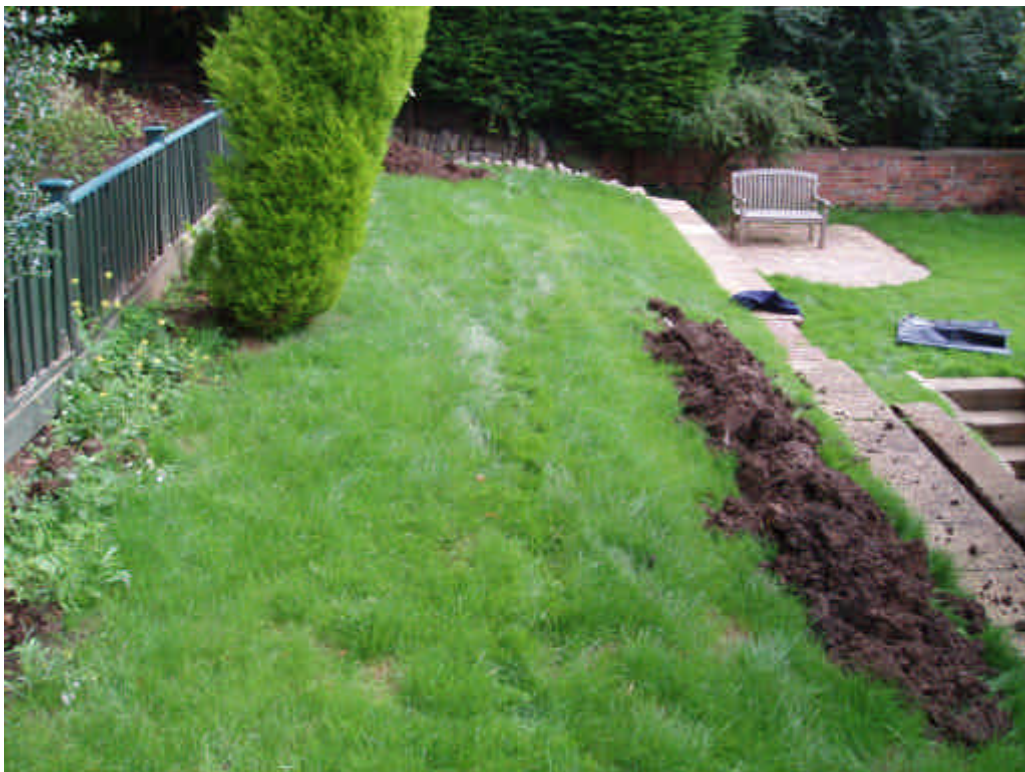
Photograph 2: Beech Cottage raised garden at start of works (August 2008)

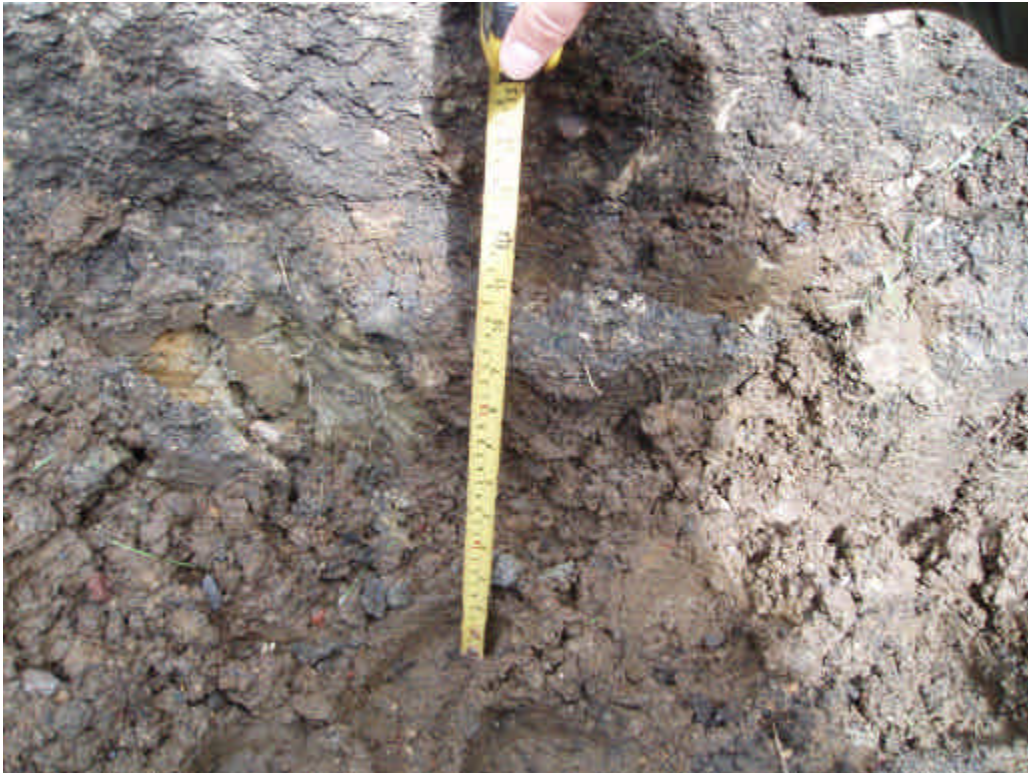
Photograph 3: Depth of excavation in main garden; 400mm (August 2008)

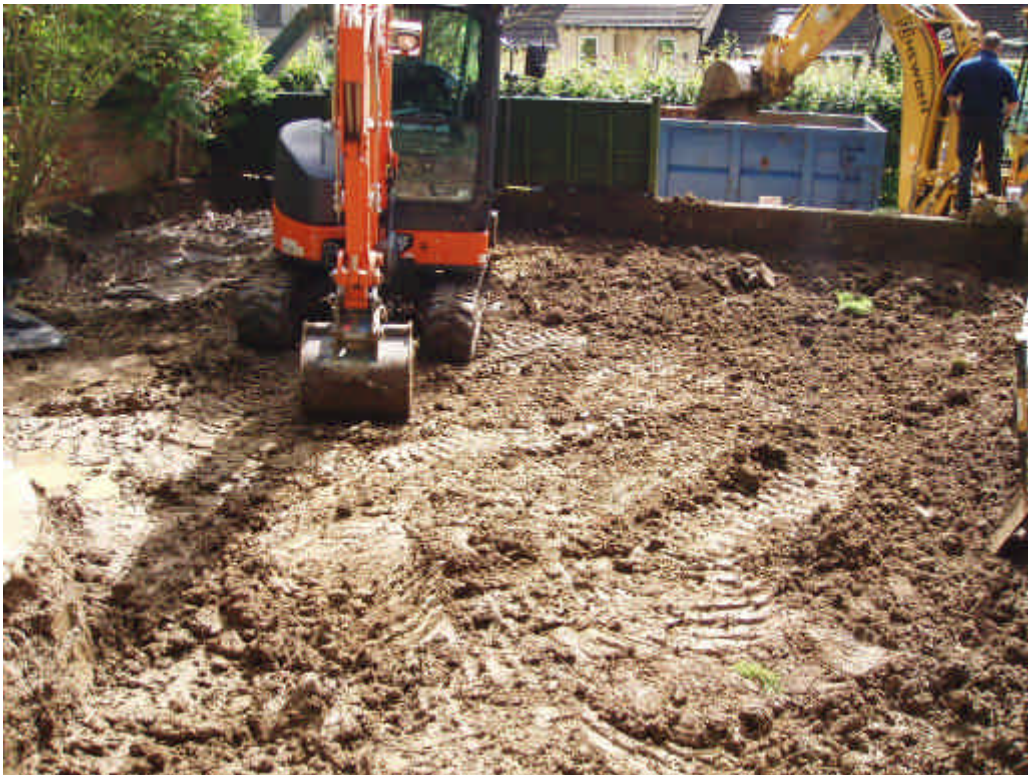
Photograph 4: Beech Cottage main garden during excavation (August 2008)

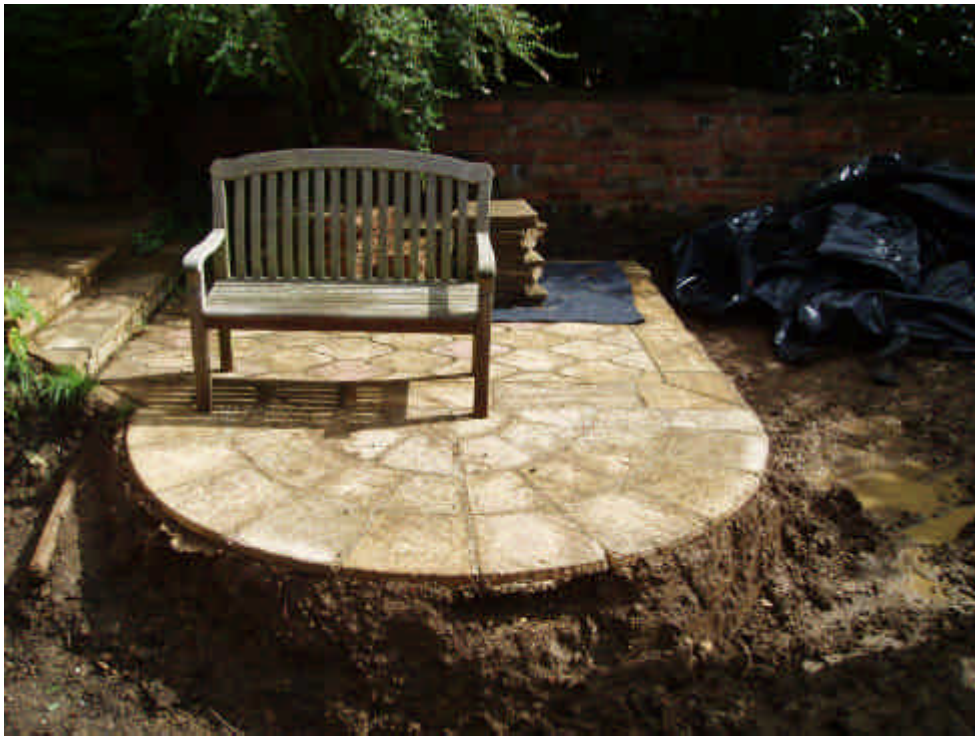
Photograph 5: Section of patio left during works (August 2008)

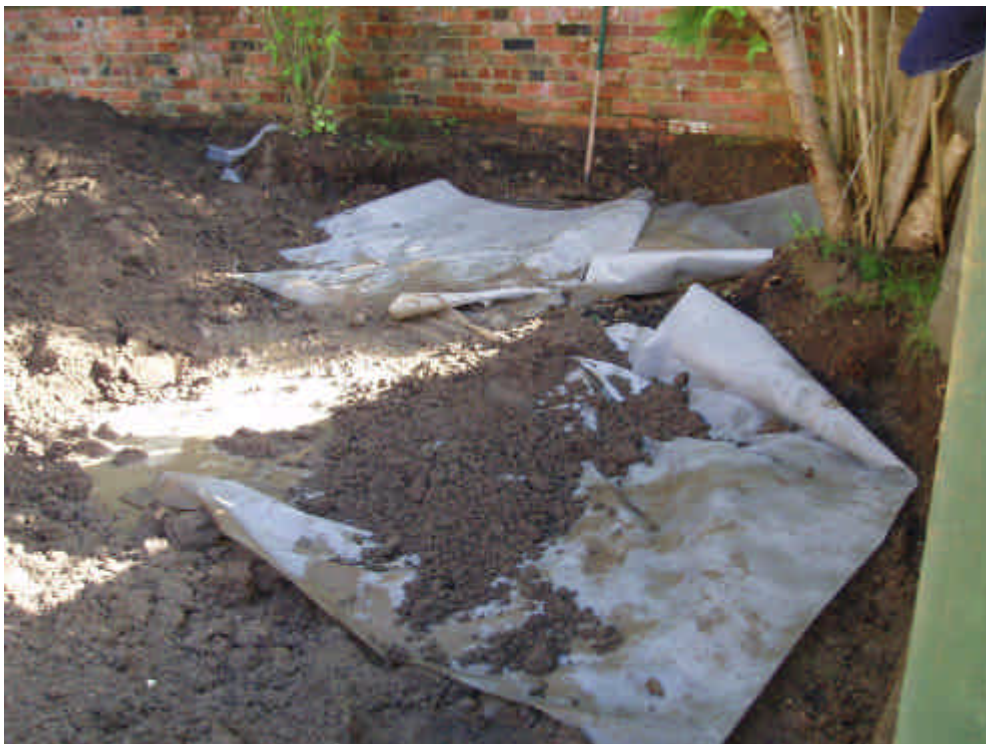
Photograph 6: New root restriction membrane installed during back fill (August 2008)

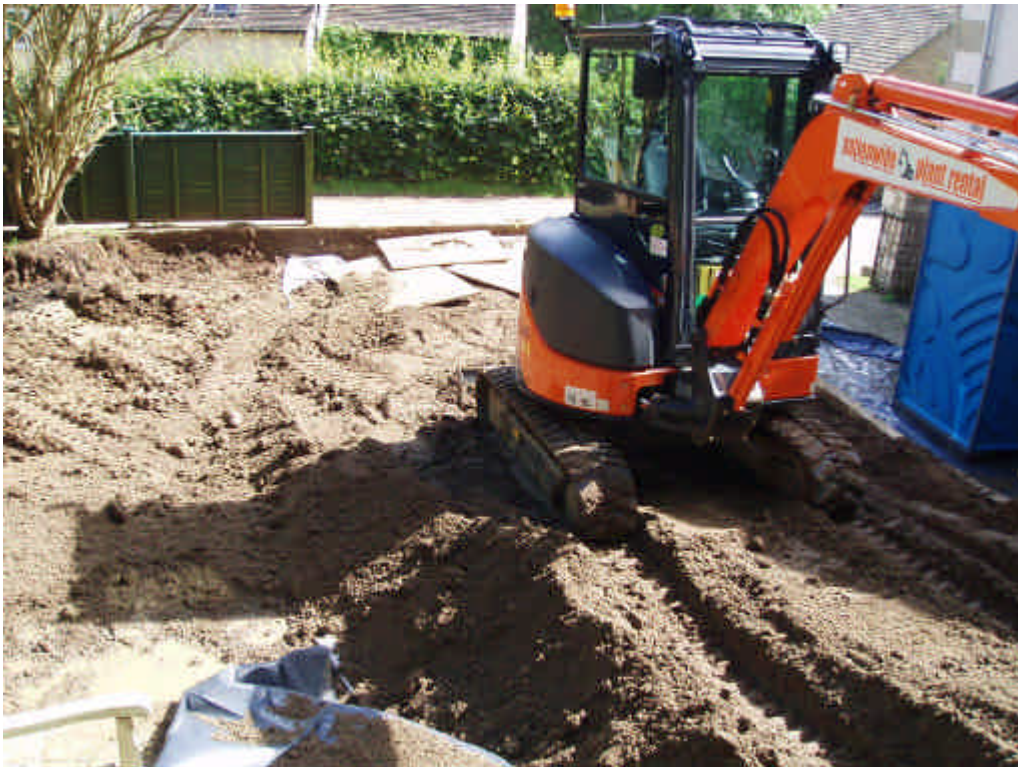
Photograph 6: Beech Cottage main garden during backfill (August 2008)

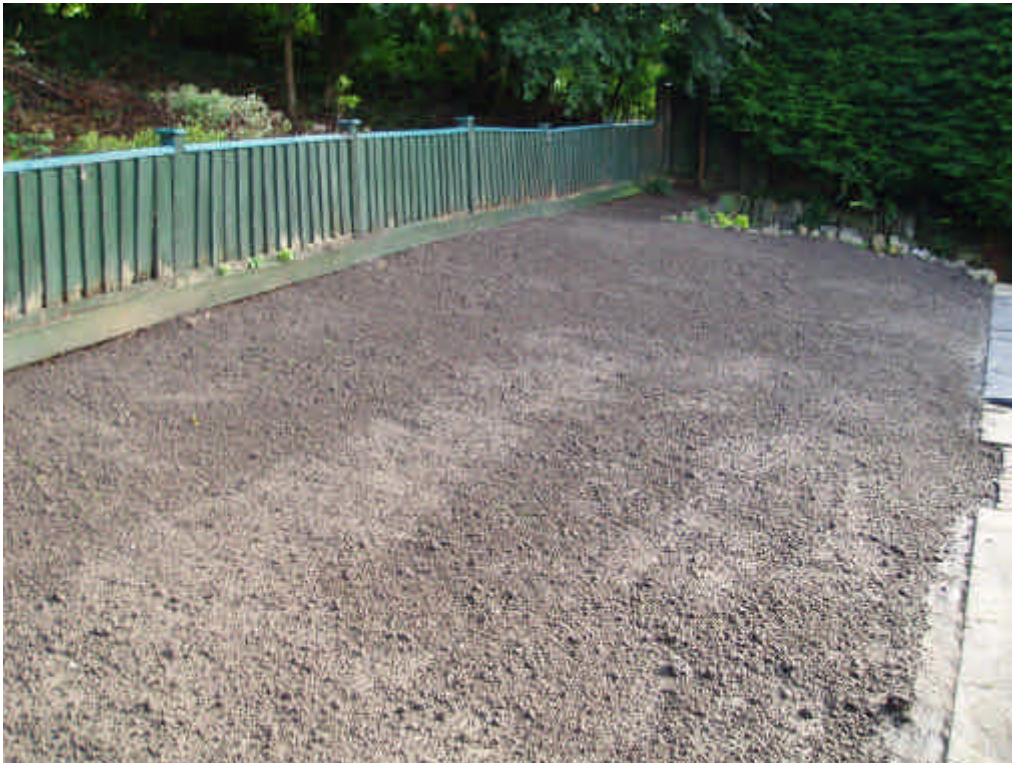
Photograph 7: Beech Cottage raised garden area after backfill (August 2008)

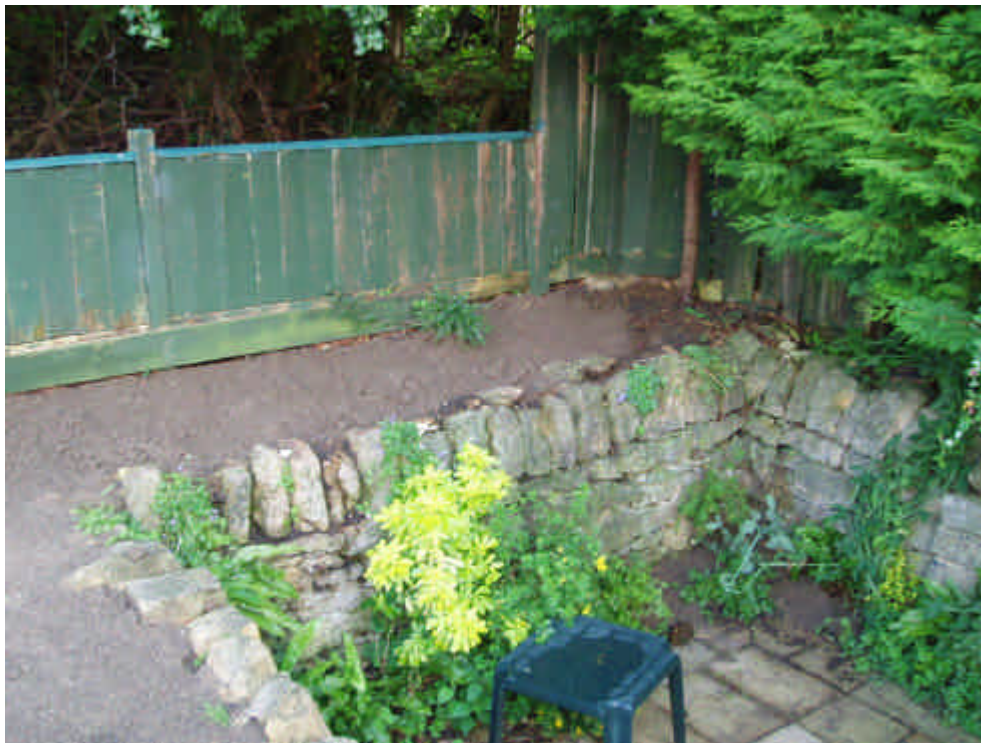
Photograph 8: North east corner of property after backfill (August 2008)
