Remediation of former Painswick Gasworks. Verification report for Beech Cottage

Report reference: 6819BR1, September 2008
Report status: Final

Confidential
Prepared by
ESI Ltd

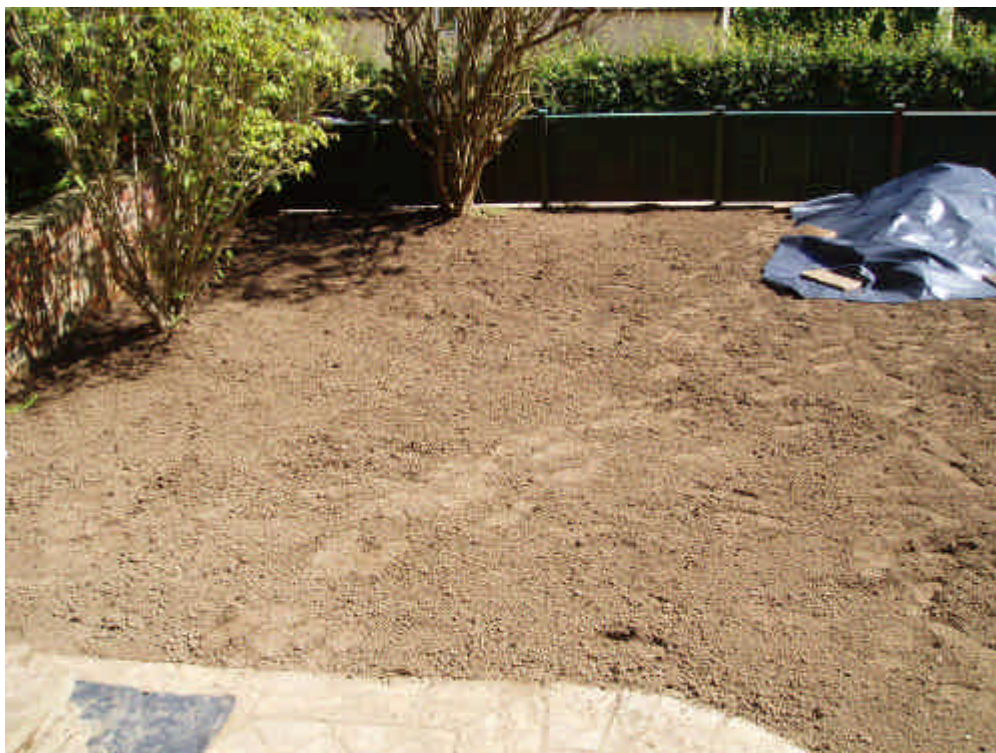
Photograph 9: Main garden after backfill including stockpile of material kept for future levelling works (August 2008)
