Remediation of former Painswick Gasworks. Verification report for Beech Cottage

Report reference: 6819BR1, September 2008
Report status: Final

Confidential
Prepared by
ESI Ltd

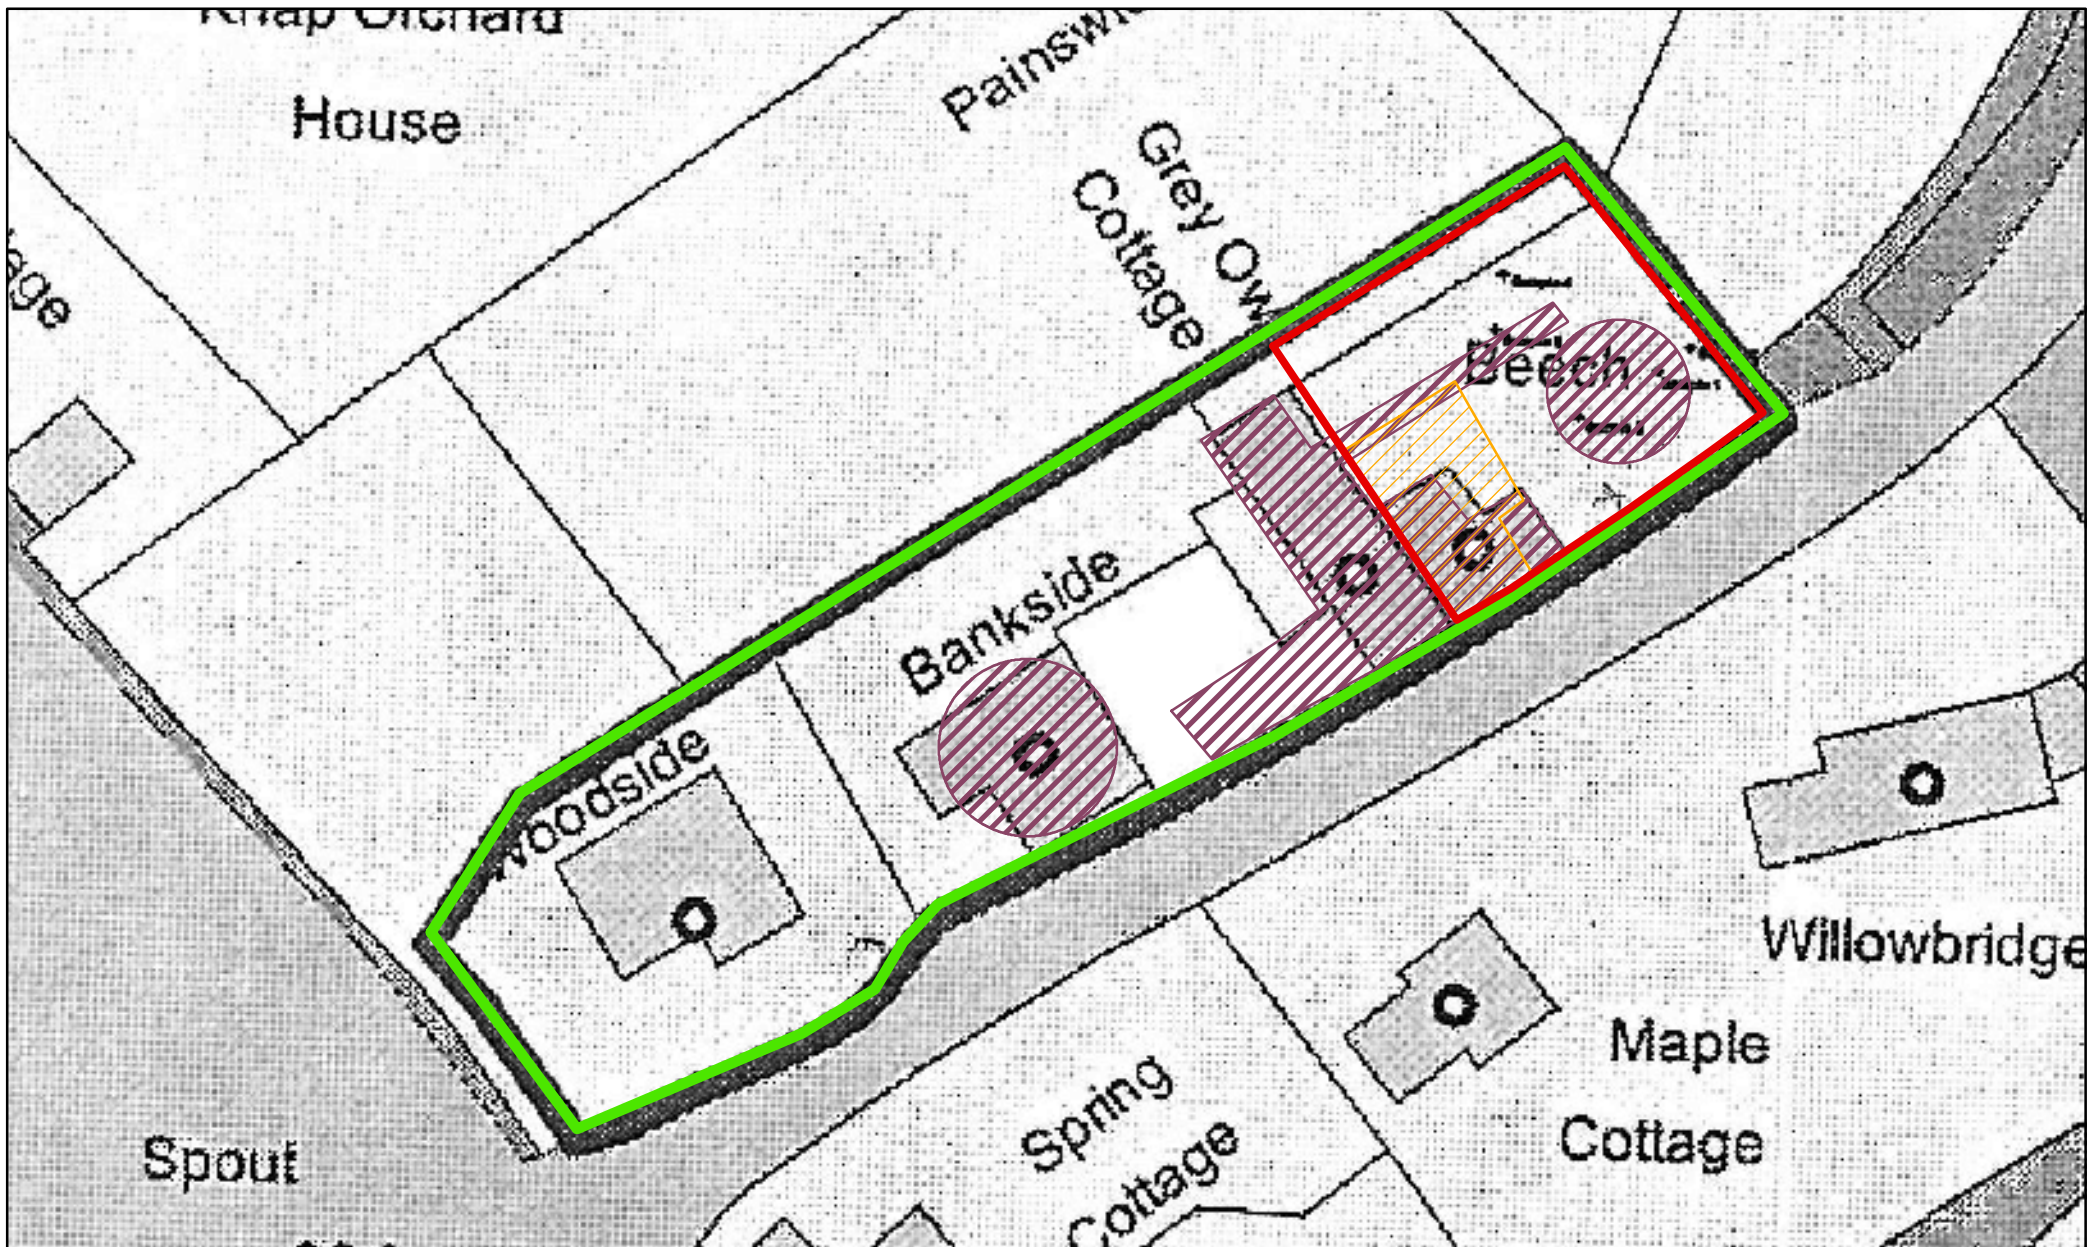
Figure 1.1
Site Setting

The gas works site, which comprised a rectangular plot of land of approximately 1500 m², was operational from c. 1860 into the mid twentieth century. The site has been sequentially developed for housing over the last 30 years. Four residential dwellings, including associated gardens, currently occupy the entire site (see Figure 1.1).

Beech Cottage is a semi-detached property located on the former site of the Painswick gas works. The cottage was developed between c. 1973 and c. 1989; three neighbouring residential properties were also constructed on the former gas works site over the last 30 years (see Figure 1.1).

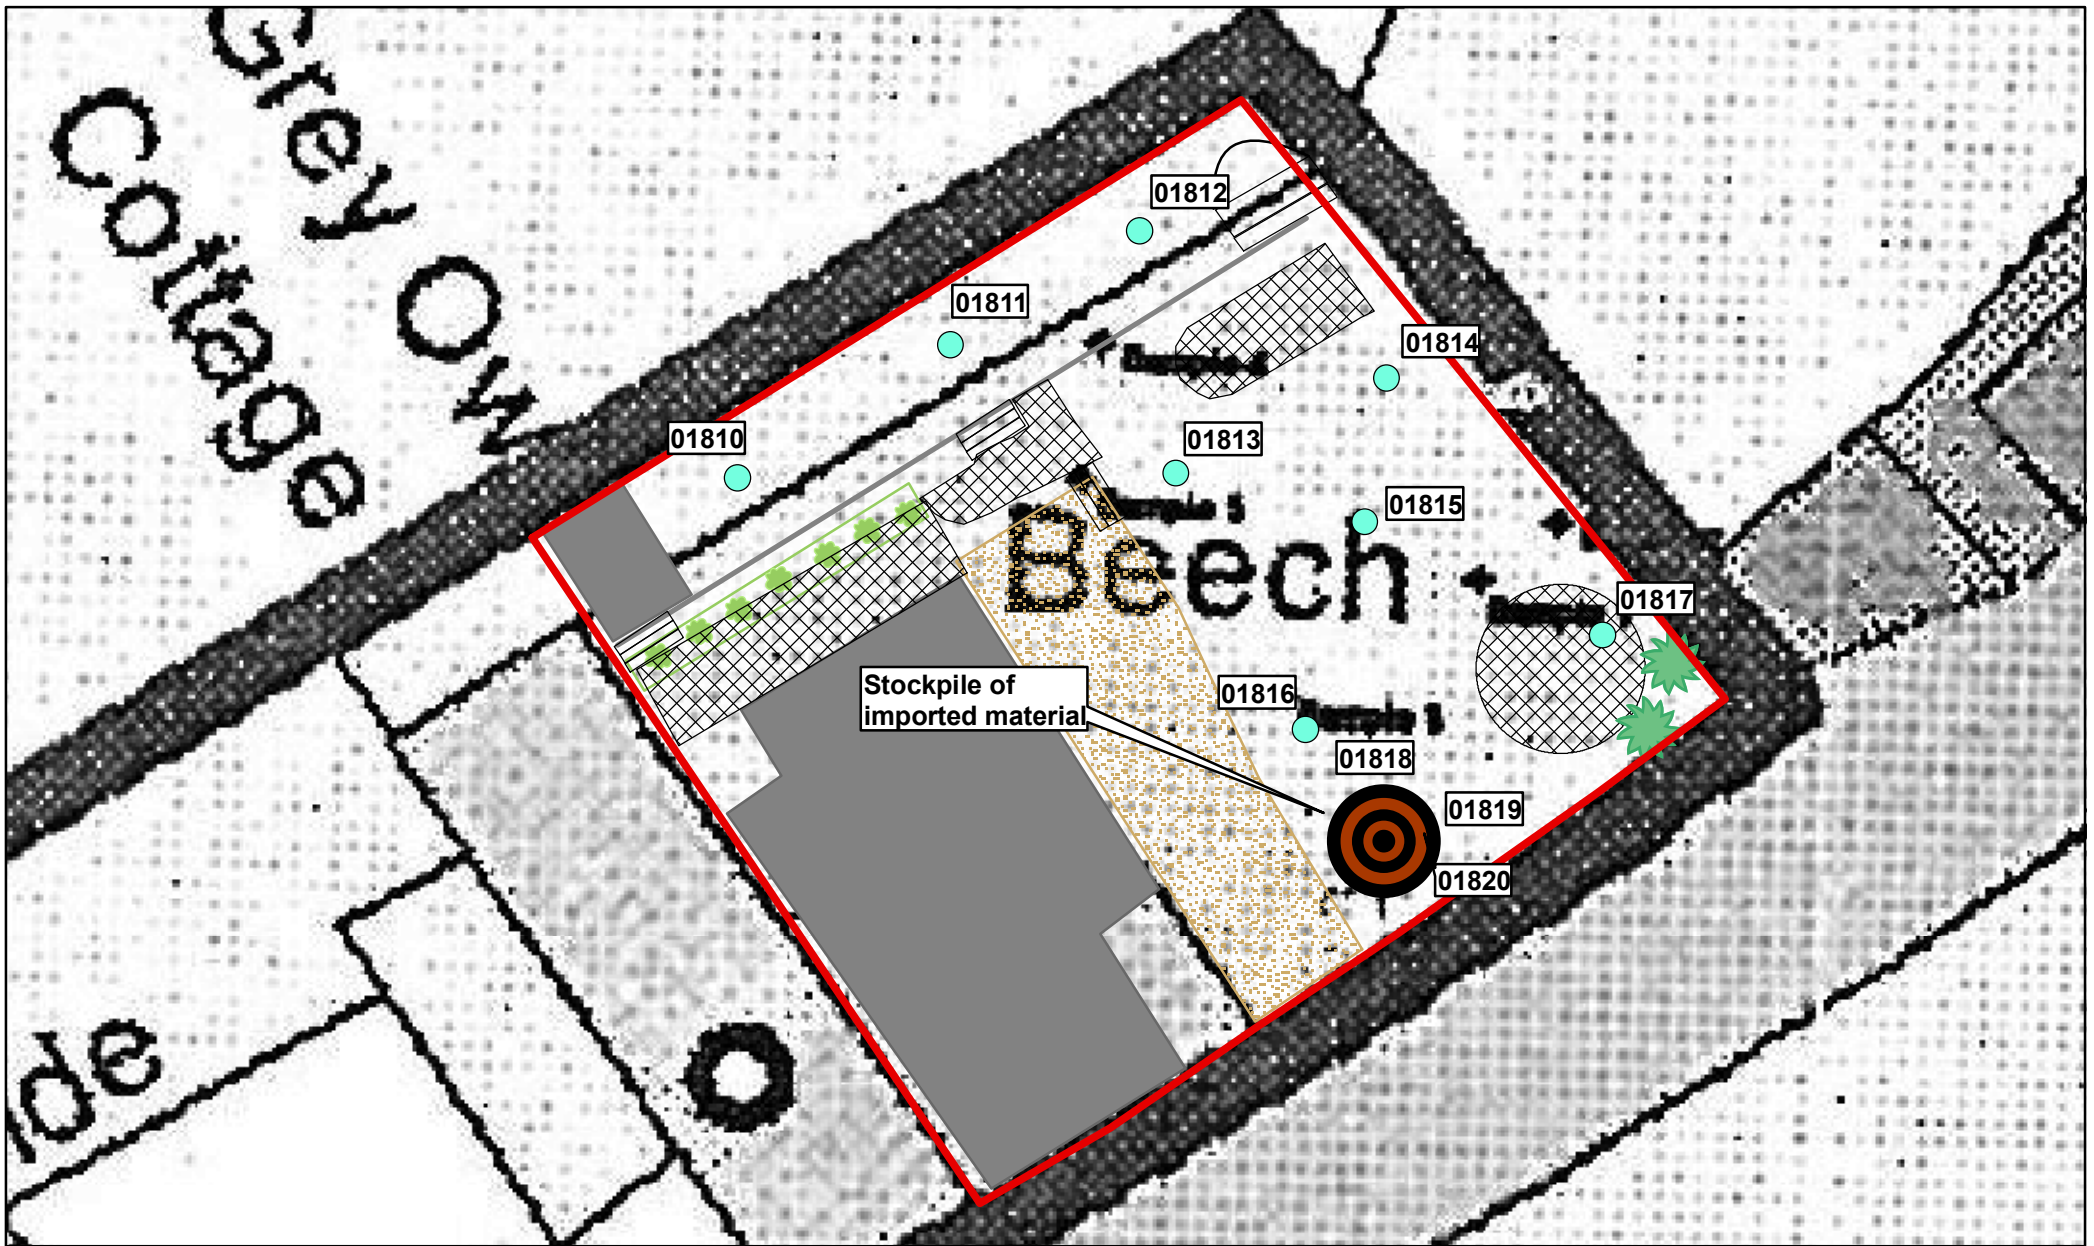
Figure 4.2
Validation sample locations: secondary remediation works (August 2008)

Further validation of the imported soil quality was conducted as per the initial remediation works, following the final placement of soils. Initially, eight validation samples were taken; three were taken from the imported soils on the raised garden tier and five from the main garden area. Following discussion with SDC, a further three samples were taken from the stockpile left on site to remedy any settlement issues identified at the time of final landscaping (see Section 3.2.4). Five of these samples were scheduled for analysis; one from the upper garden (01811), two from the lower main garden (01813 and 01817) and two from the stockpiled materials (01819 and 01820). This resulted in a sampling frequency of approximately one sample per 10 to 15 m³ of imported soil. The approximate position of the validation samples is shown on Figure 4.2. The remaining six samples were put 'on hold' (note: there was no subsequent requirement to schedule these samples for testing).
